Case Study

Cesspit Waterproofing – Shrewsbury, Shrops

Client: Mr Lawrence & Mrs Walters

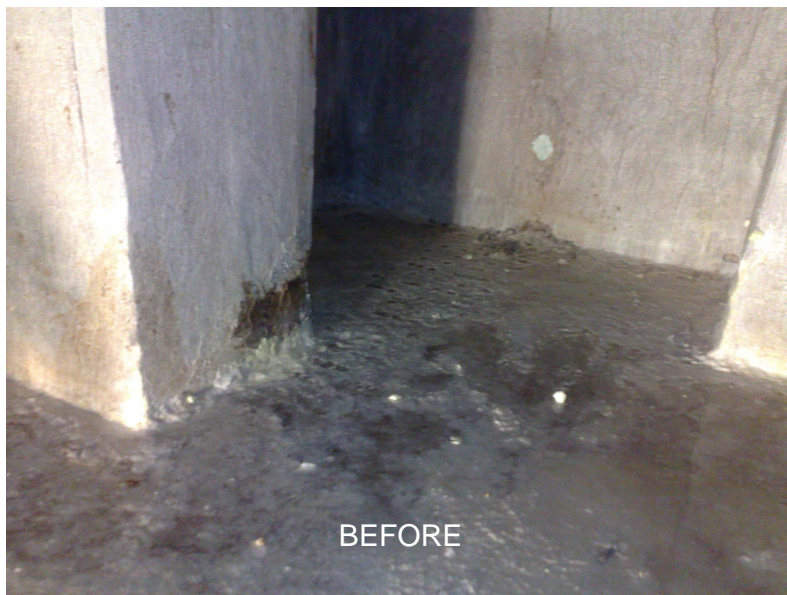
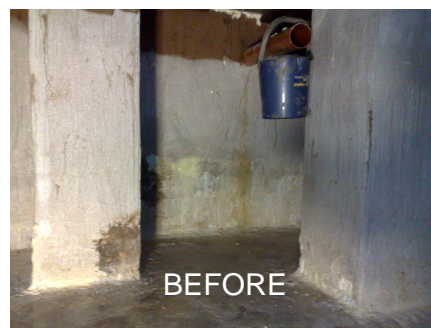
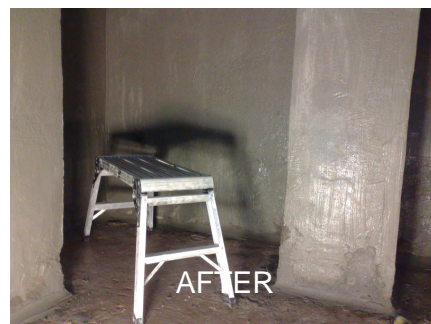
18th Century Church in a rural setting 5 miles outside Shrewsbury, Shropshire had a cesspit build to accommodate inhabitants under new government guidelines. Built from blocks with a concrete base and render finish it had no waterproofing at all.

After the initial build it began to leak and several attempts were made to waterproof the pit, unsuccessfully. Water was coming in at such a rate it would have filled the pit three times as fast as designed, meaning much more frequent, and very costly emptying. Beautiful Basements were called in to try and solve the problem. The substrate was extensively cleaned and taken back to the original render, any defects in render or concrete on the floor were repaired and all surfaces in the pit were primed and waterproofed using a range of Koster Aquatecnic's cementitious range of slurries.

Waterproofing Method: Cementitious waterproofing slurries from [Koster Aquatecnic](#)
